BUCK HORN LAKE DAM

OTSEGO COUNTY
NEW YORK

INVENTORY NO 362

PHASE I INSPECTION REPORT
NATIONAL DAM SAFETY PROGRAM

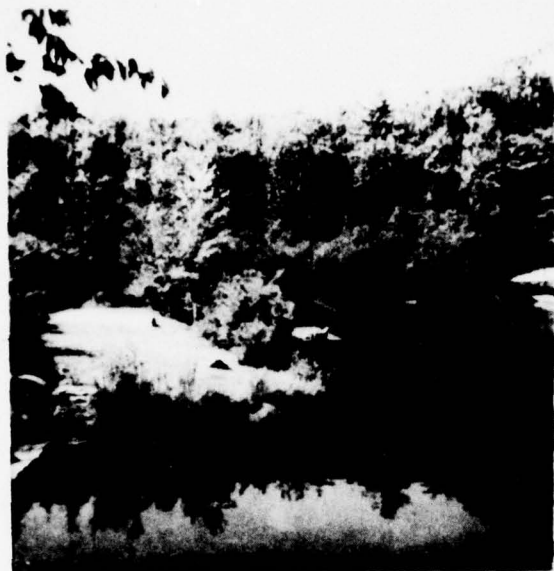
1. View looking west across face of dam.
Spillway is in left portion of picture.

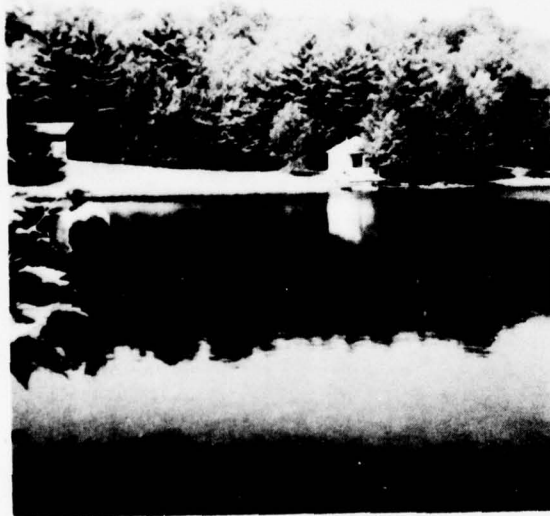
2. View looking west shows typical over-bank area and structures close to the water's edge.

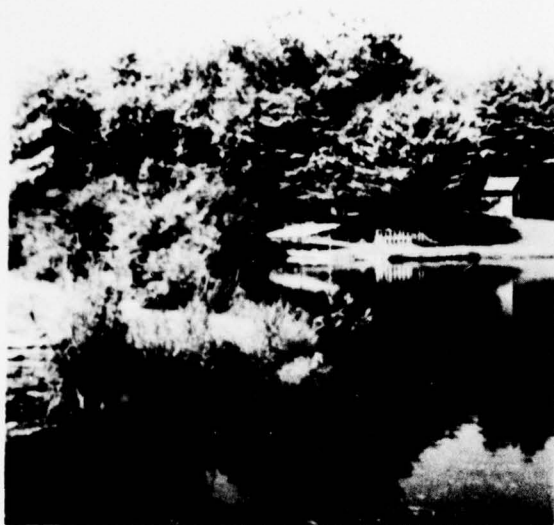
3. Another view looking west showing lawns and docks in the area.

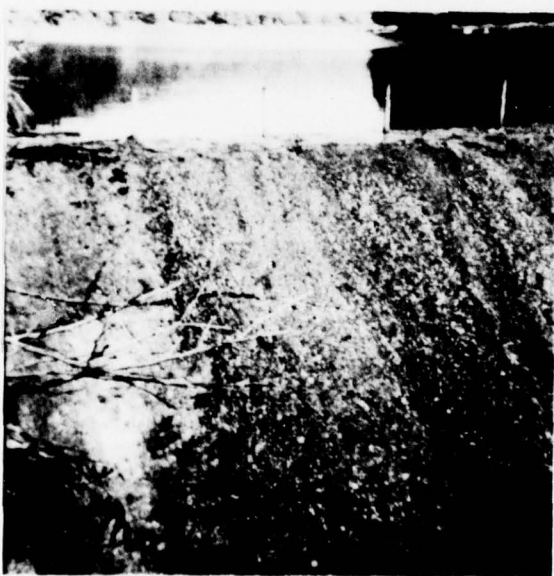
4. Closeup of spillway surface which is in serviceable condition with some surface erosion.

The concrete spillway is in generally good condition. At the time of the inspection the spillway was covered with dry algae; a small flow was observed over the top of the spillway. The face of the spillway is somewhat eroded. A small crack exists across the face of the spillway.

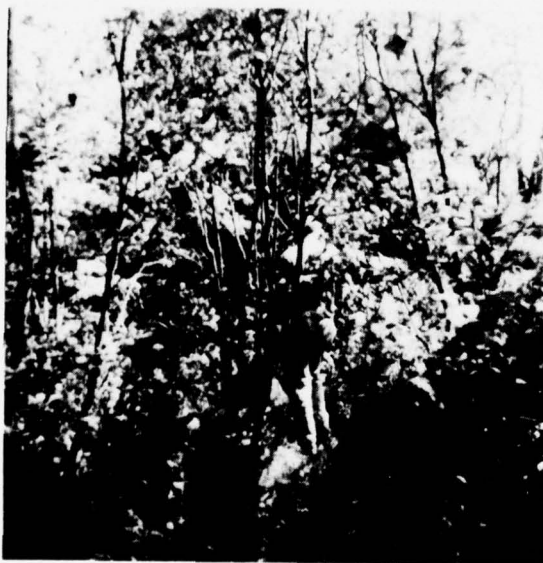
6. Typical picture showing treed area on top of dam.

- 1) Trees and brush should be removed from the dam surface and the areas should be seeded and mowed so that they may easily be inspected. Trees and stumps should be removed from the abutments and the stump holes should be properly backfilled with impervious material.
- 2) Riprap should be placed on the upstream face of the dam at the waterline to provide adequate protection from wave action.
- 3) The drainline from the dam should be inspected throughout its length to determine the amount of deterioration that has taken place in areas that are not visible from the outlet end. The drainline, if severely deteriorated throughout its length, should either be replaced or relined and grouted. The shear gate controlling the dam outlet pipe should be accessible for operation from the water surface.

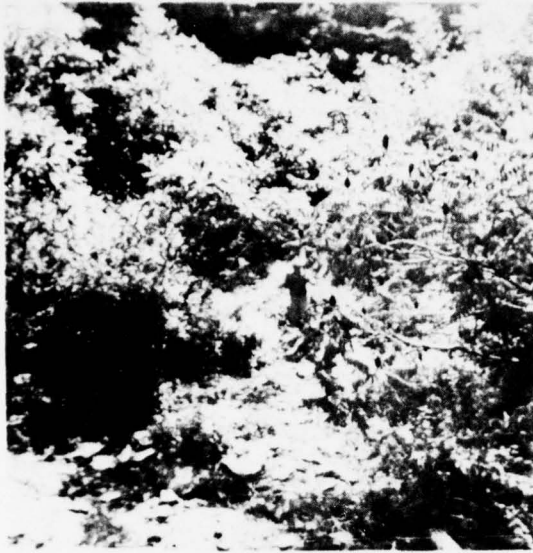
7. View of downstream spillway channel.

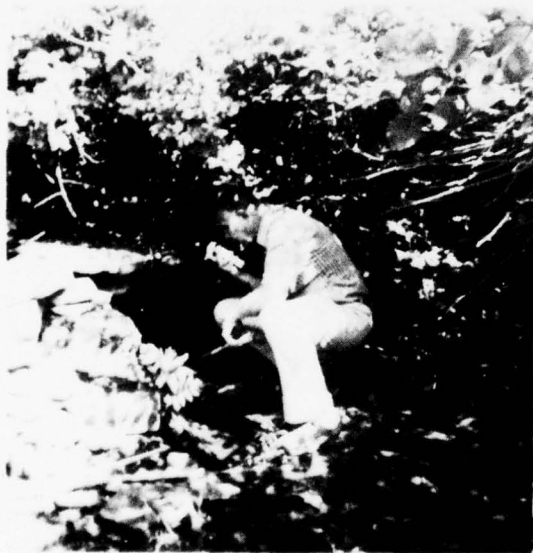
8. Outlet pipe area.
